Further to us attending the above property on 7th May 2019, to investigate a blocked sewer and reported foul odours, we can summarise our findings below. These are to be read in conjunction with the full drainage report and plan attached.

Further to us attending the above development on 13th & 14th May 2019 as follow on work from a previous visit, we can summarise our findings and works below. These are to be read in conjunction with the full drainage report and plan attached.

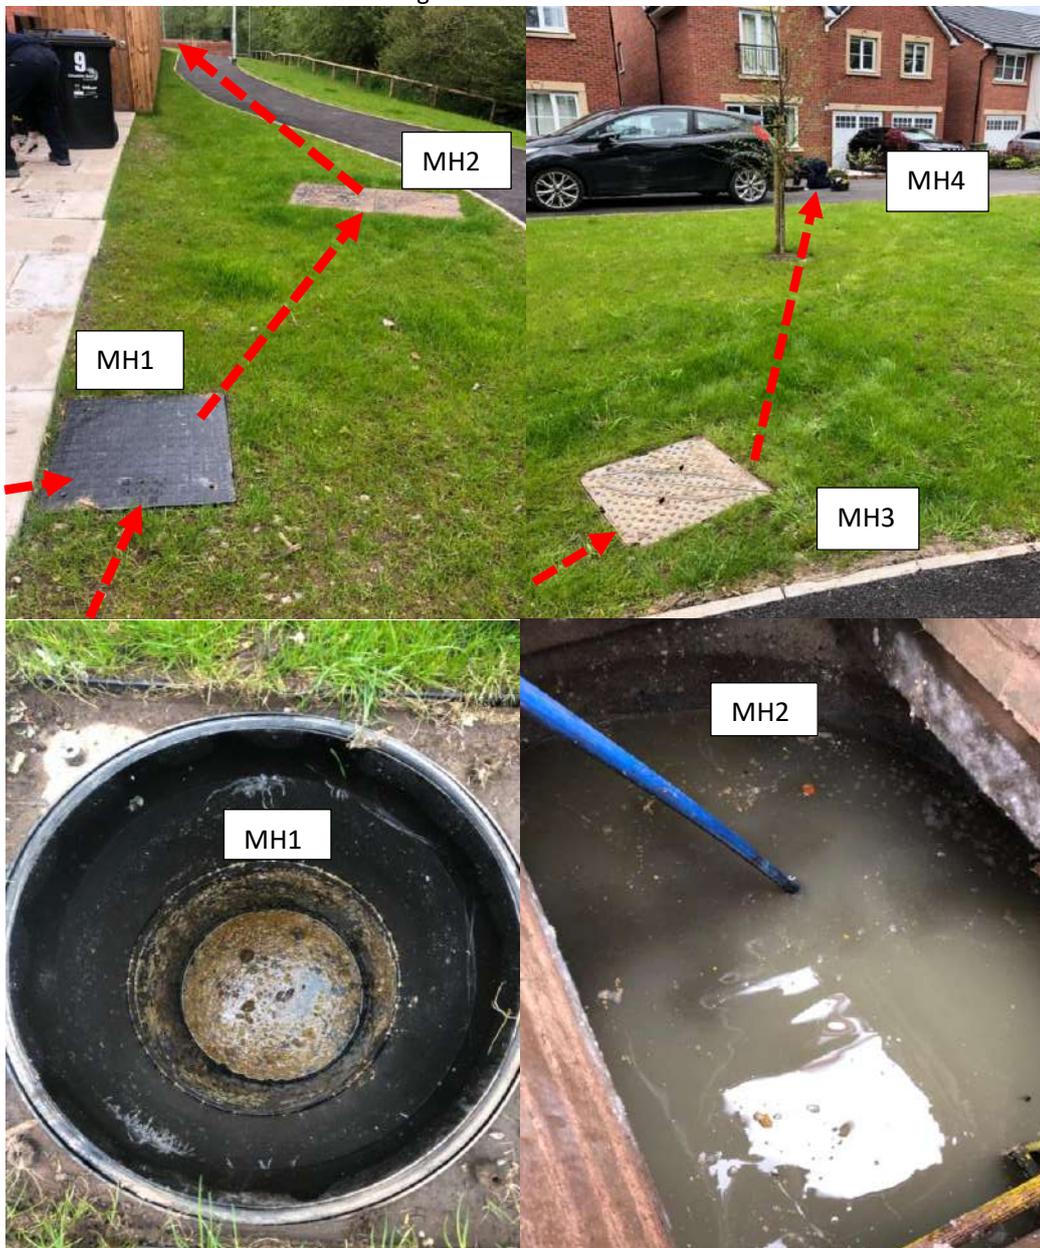
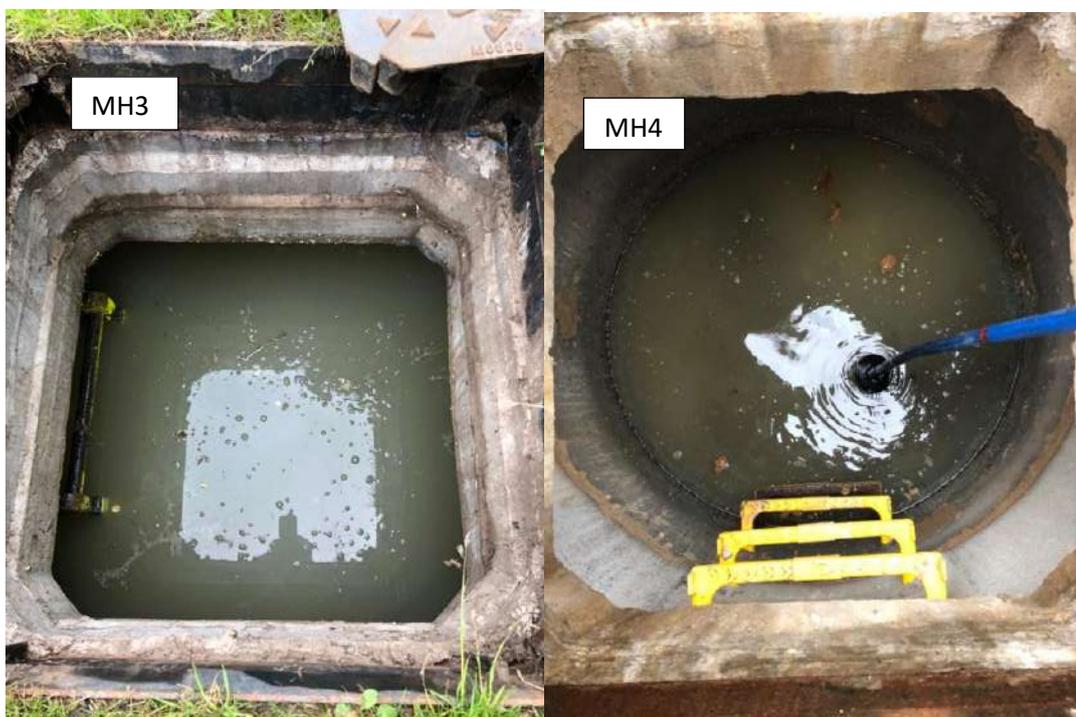
1. We attended the above property and upon lifting various manholes to the front, found two of them to be fully surcharged. MH1 & MH2 on plan. We then moved Downstream to the next manholes on the run and found them to be surcharged MH3 & MH4.

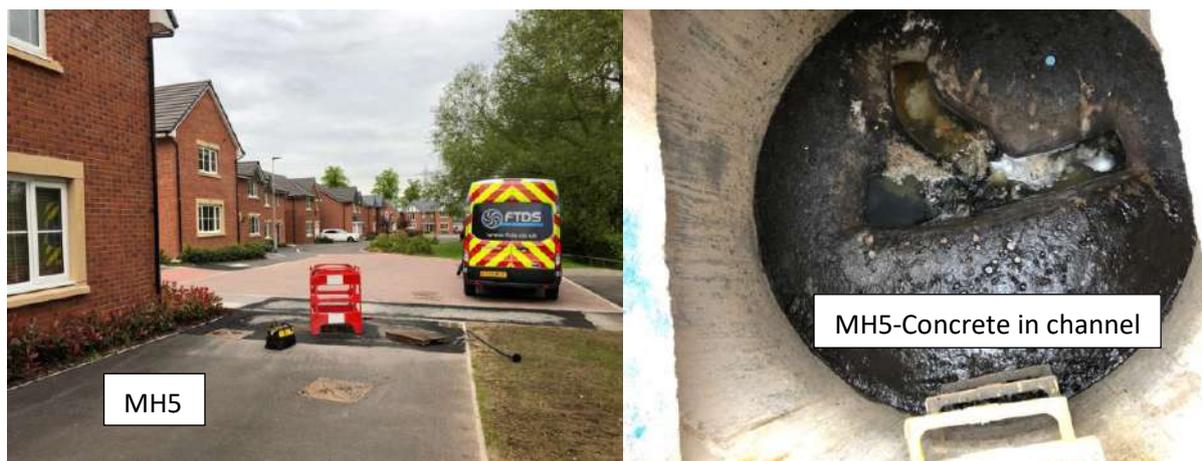
2. We then moved again downstream and found MH5 to be flowing slowly but it had a large amount of concrete and stones in the channel which was severely restricting the flow and causing a blockage.

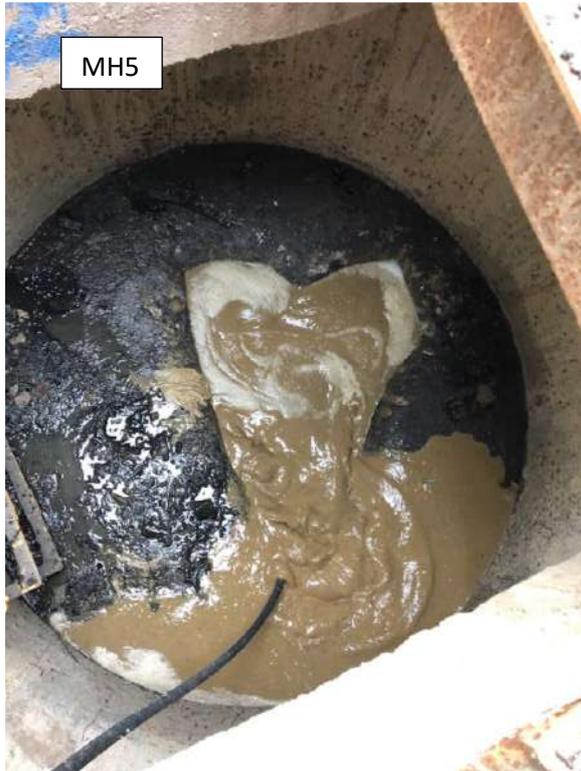
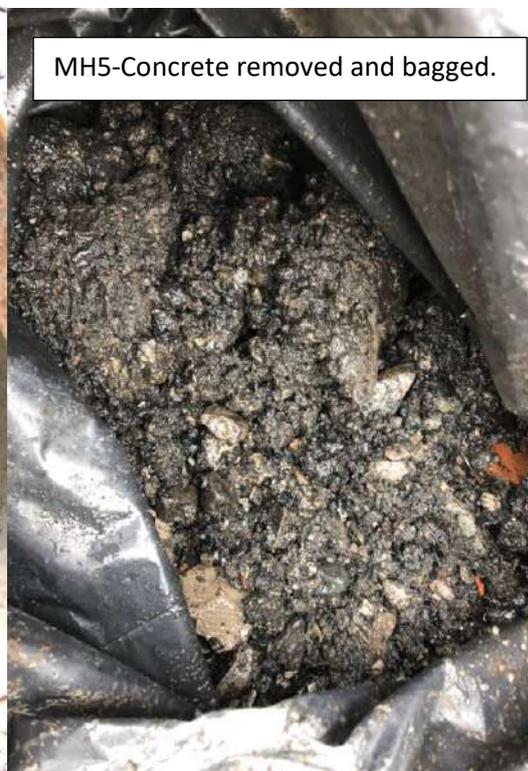
3. After discussing with Eric on site and emailing the office we proceeded to enter this manhole and break out the concrete, remove the debris and this in turn released some of the water flow.

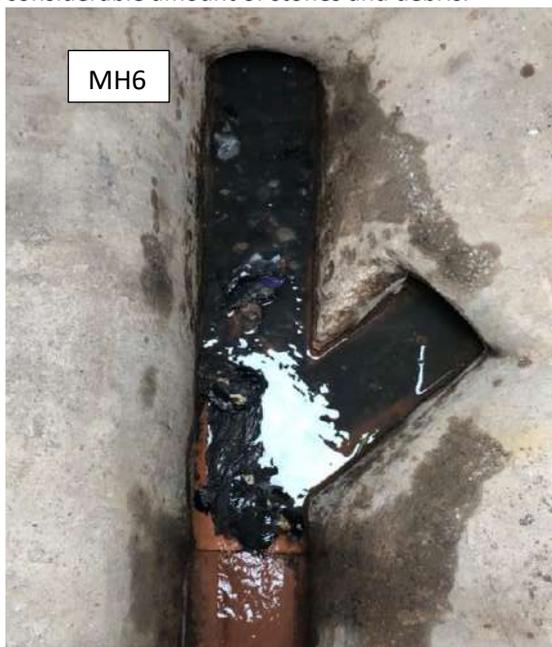
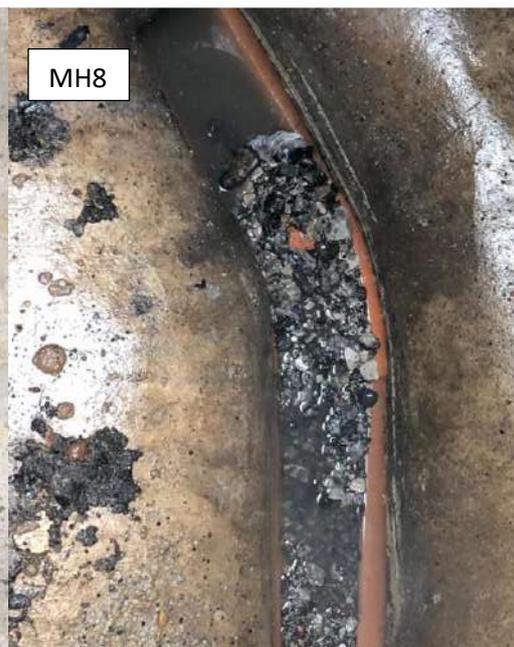
4. After allowing the water level to fall, we then CCTV'd the line from MH5 upstream to MH4 and found the line to contain a considerable amount of stones and debris which we then continued to jet and clean. We removed more stones from this line but water was again holding in the downstream section between MH5 & MH6. We had a look with the camera and found it again to contain a considerable amount of stones and debris.

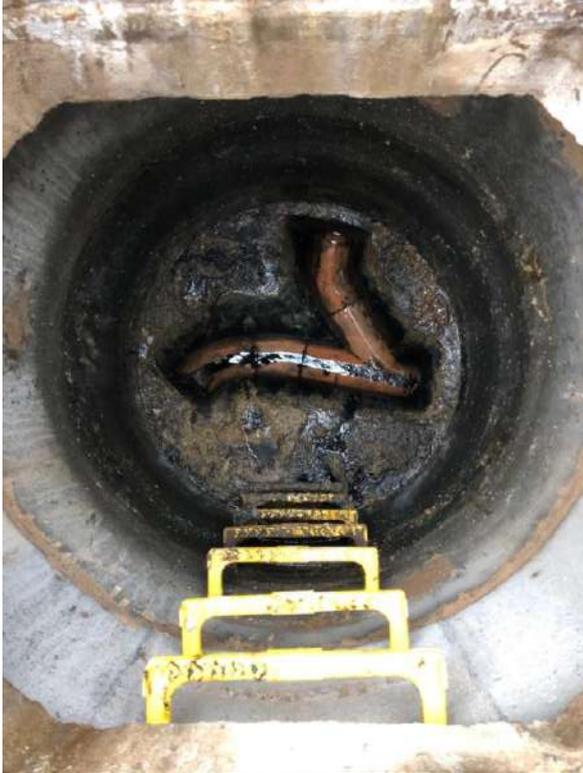
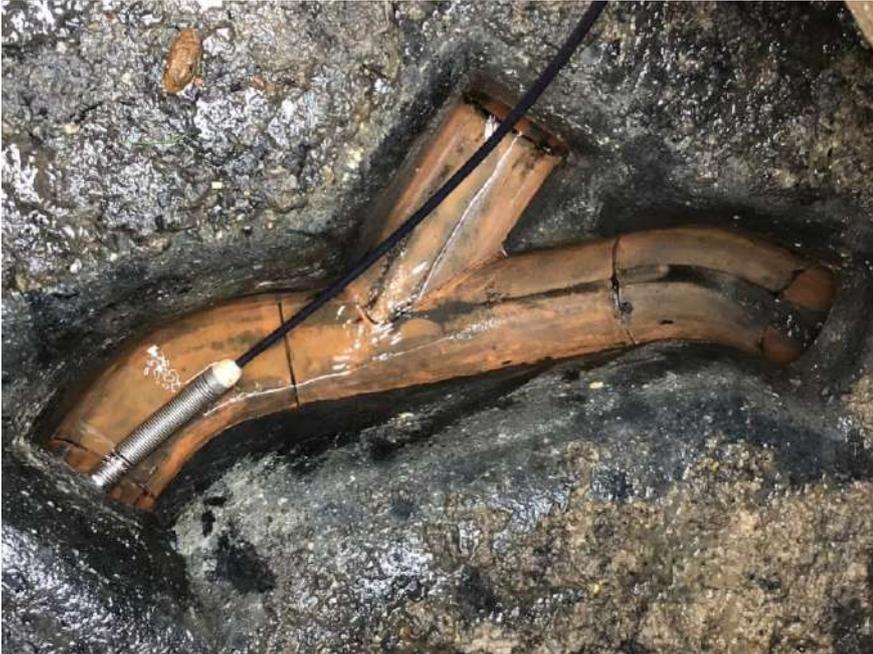
5. After considerable cleaning, we moved back up to No9 and managed to CCTV the lines from here downstream to MH3 but found that there are still stones in the line which will require removal to prevent the possibility of further blockages. All of the channels in the manholes were left running freely but all manholes require cleaning to remove all the build-up of effluent to prevent it drying out and causing potential odour issues for the residents. We were unable to complete this as the debris washing down the channels could have caused further blockages as it met the stones still in the line further downstream.

We would recommend a full cleanse of the drainage system from the head of line upstream along its full length to where it leaves the site. The amount of stones and debris within the sewer are currently preventing a good flow for the drainage and will continue to cause problems, cleaning and surveying line by line from top to bottom is the only way to ensure that the system is clean and efficient.

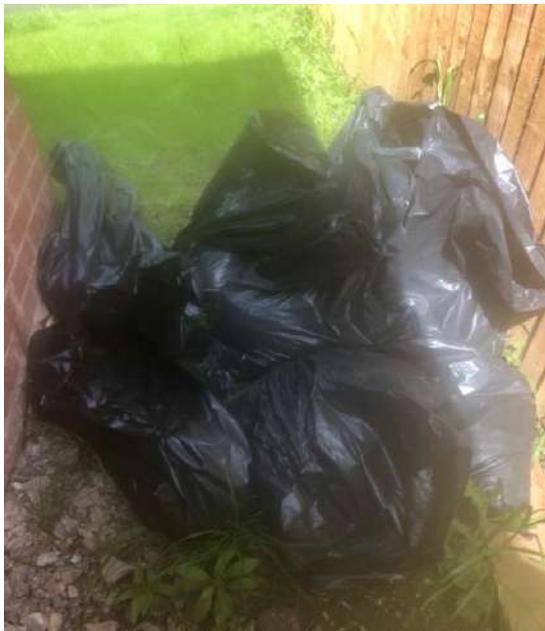
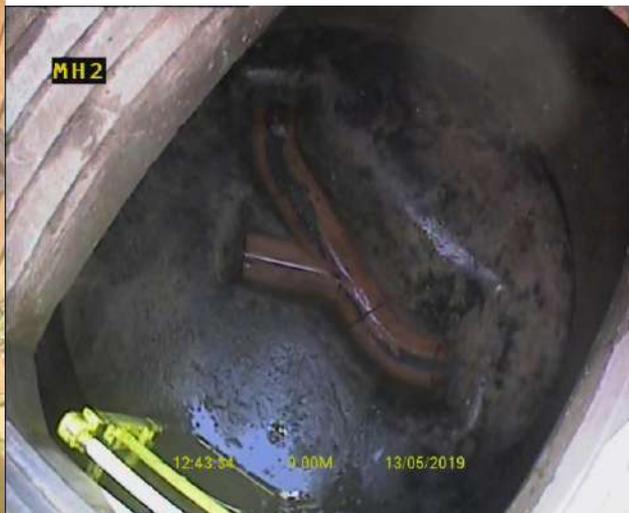
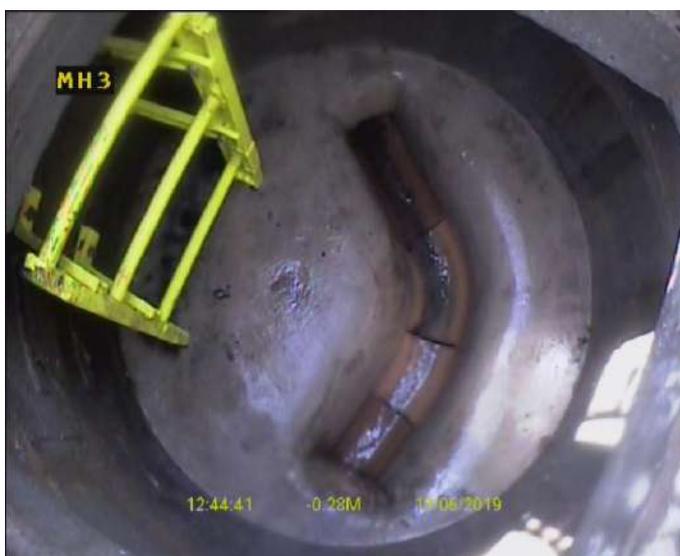
1. We began our cleaning between MH2 & MH3 as this had been identified as the area causing major blockages to the system. We spent the full day jetting and removing rubble and building debris from this line and estimate that around 750kg were removed leaving the asset totally clean and flowing well. Both manhole chambers were cleaned down and disinfected to help disperse the odours.
