Further to us attending the above property on 27th January & Tuesday 4th February 2020, we can confirm our findings below :-

Surface water System

Foul Water System.

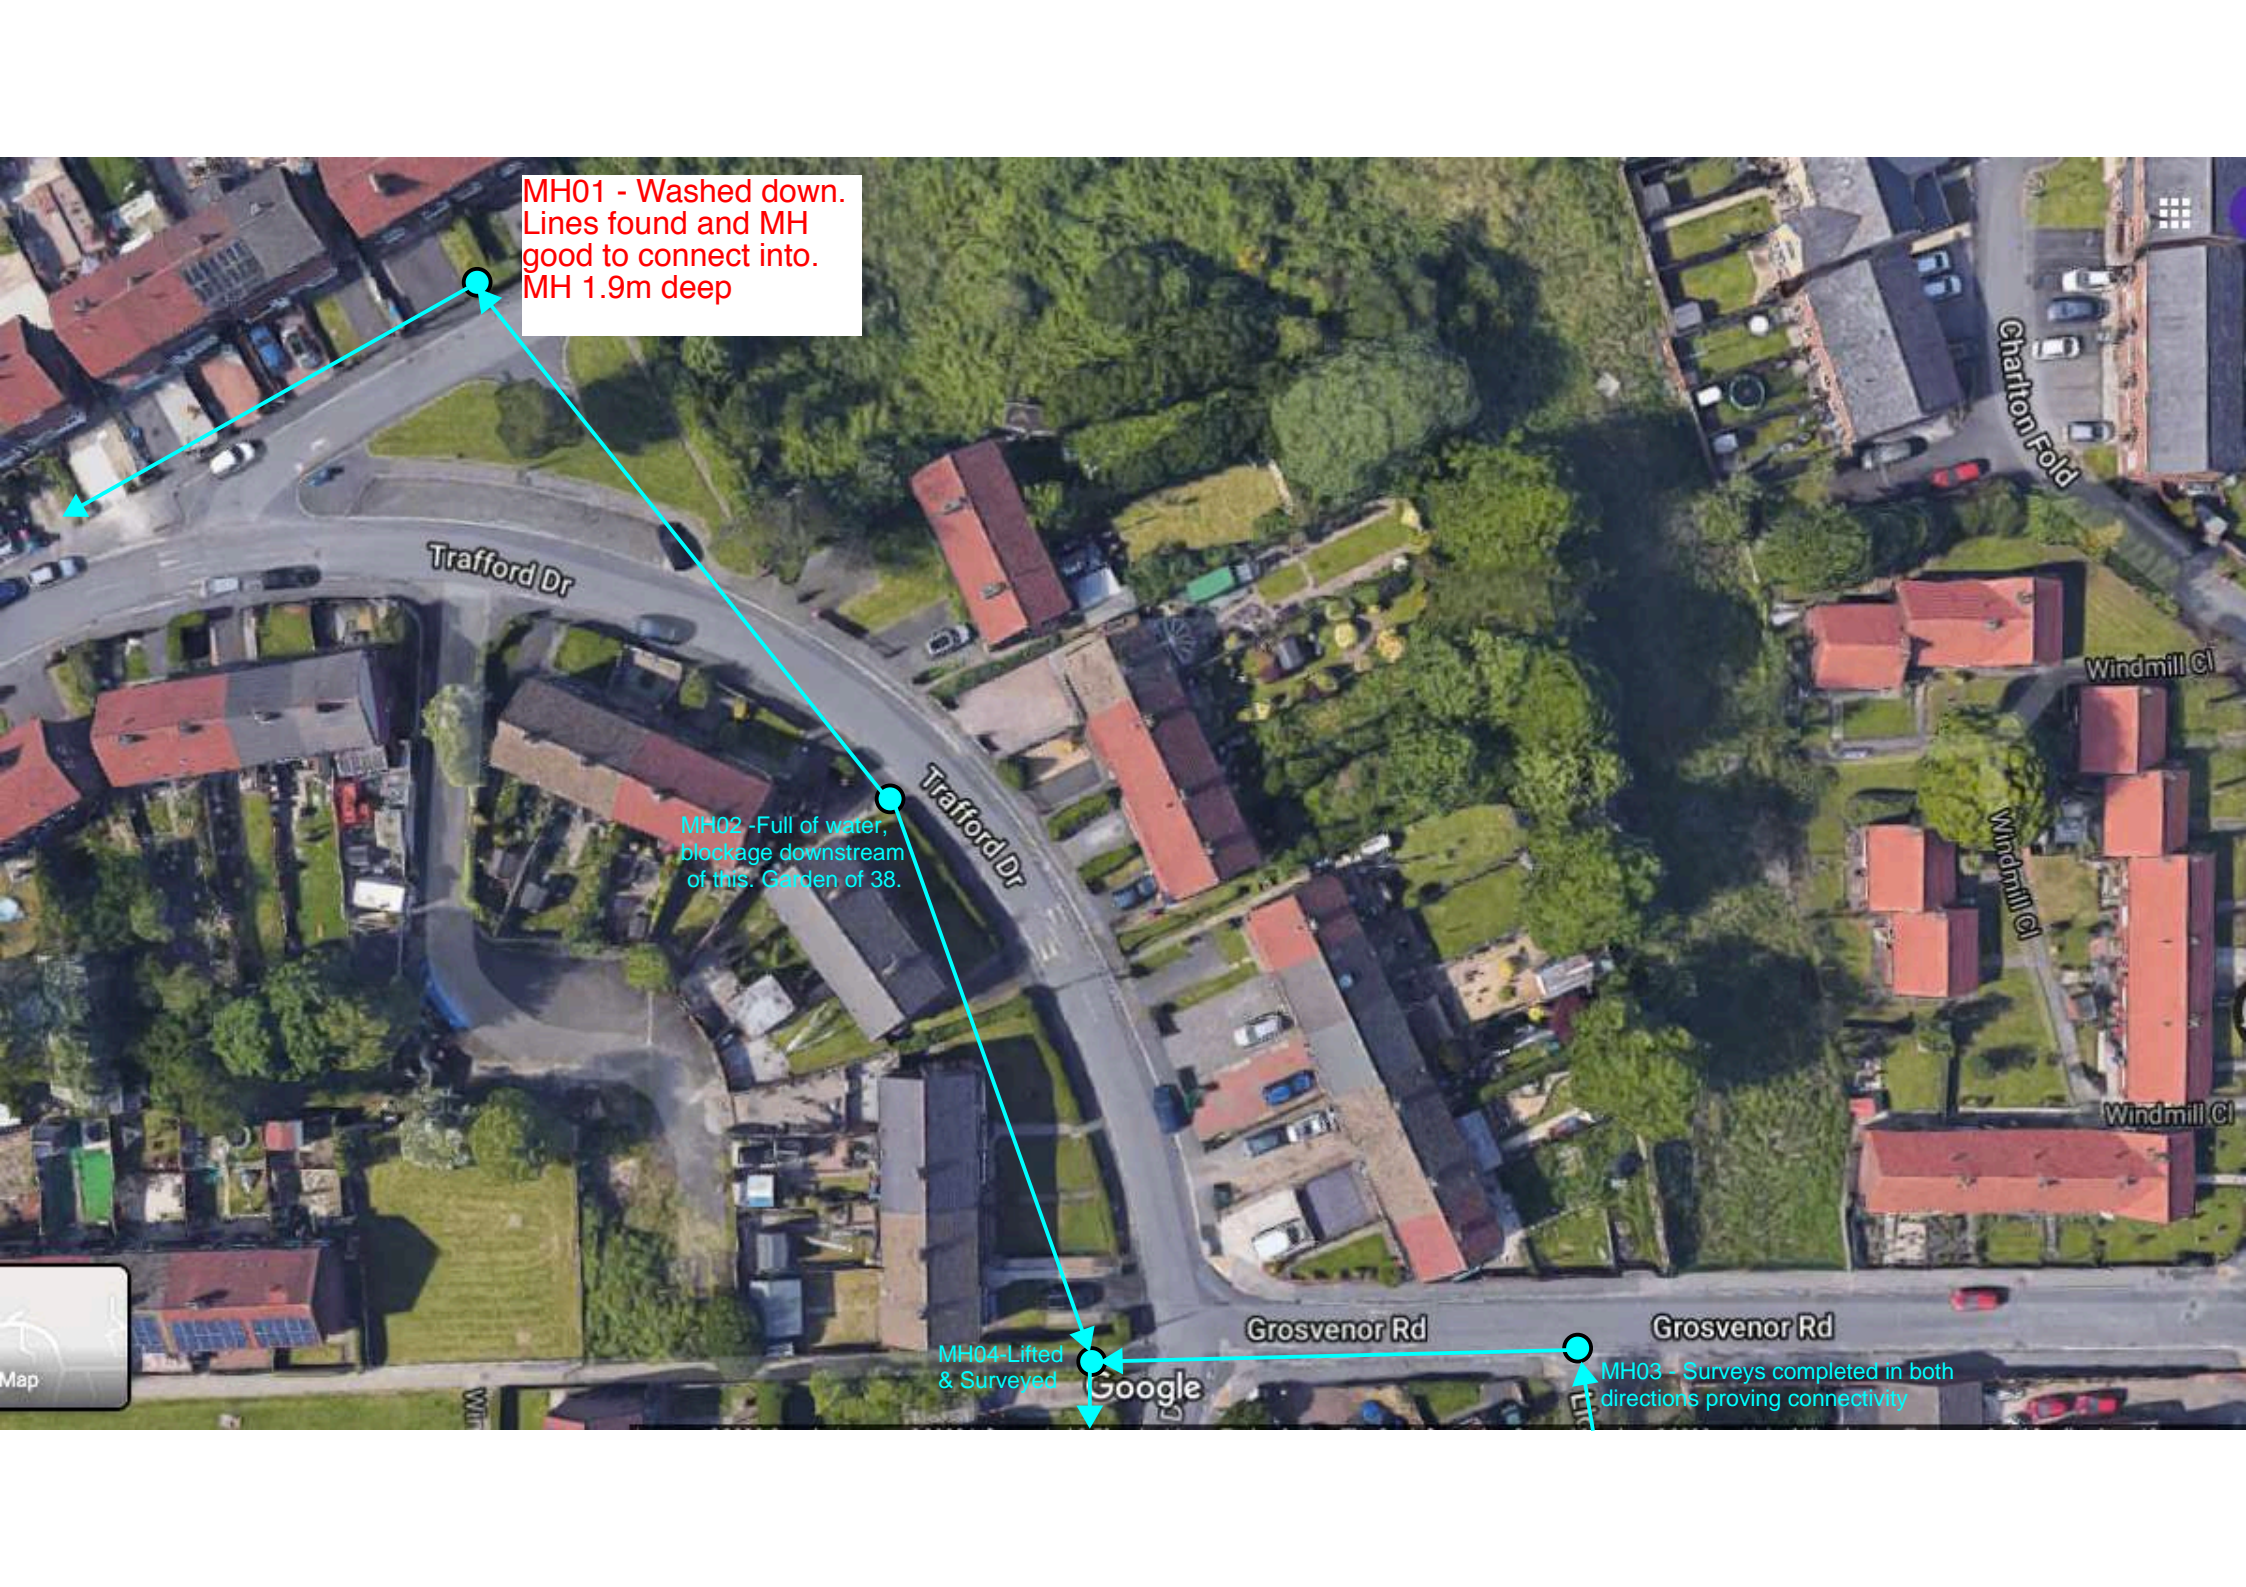
MH01 - Washed down.
Lines found and MH
good to connect into.
MH 1.9m deep

MH02 - Full of water,
blockage downstream
of this. Garden of 38.

MH04 - Lifted
& Surveyed

MH03 - Surveys completed in both
directions proving connectivity

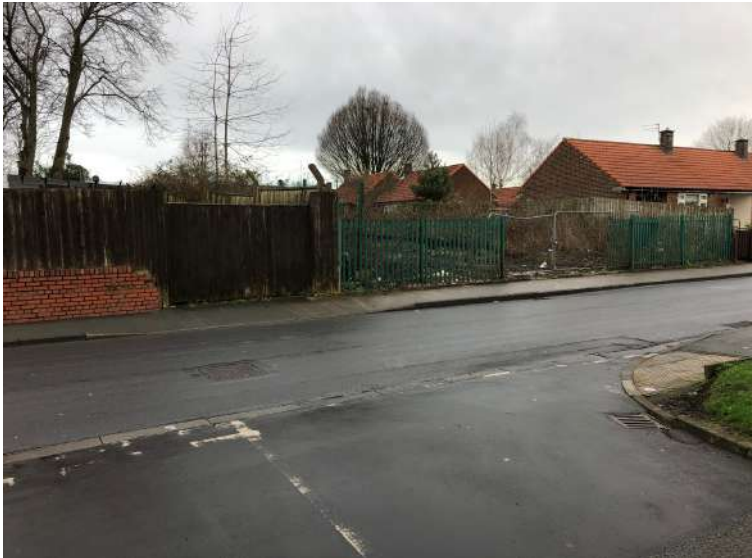
Photograph 1

This section was in a good condition, of 225mm diameter pipes and at a depth of 1400mm to the invert of MH03. Chamber inspection report attached along with the drainage report for the incoming and outgoing pipes.

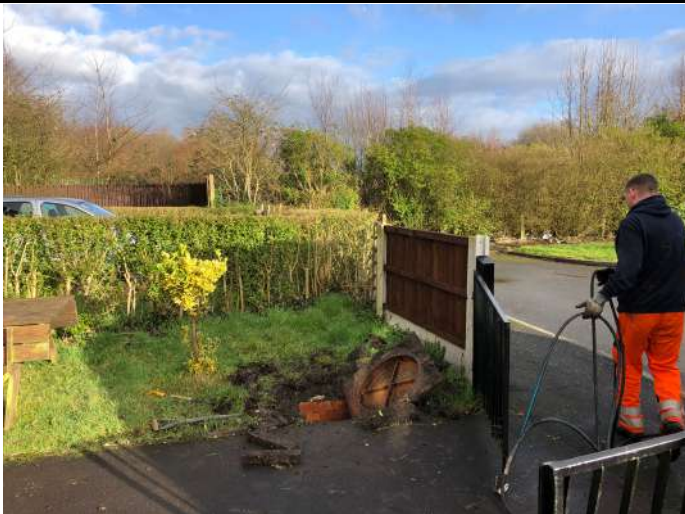
Photograph 1

The SWS at the North West of the site was found to be located in the front garden of No.53, MH01, and was showing signs of neglect. We jetted the lines coming into MH01 to try and obtain CCTV footage but all lines are surcharged and require a full cleanse from UU. MH01 was also found to have a substantial amount of slit/soil in the bottom but we did manage to find the incoming assets x2 and outgoing asset x 1. These were all 150mm in diameter and between 1850mm & 1900mm deep to invert in MH01.

Wet Beds, signs of flooding	<input type="checkbox"/> YES <input checked="" type="checkbox"/> NO	Chamber Construction - Brick, Concrete, GRP, Other (Please State)	<input type="checkbox"/> Brick
Cover Obstructed	<input checked="" type="checkbox"/> YES <input type="checkbox"/> NO	Cover Material - GRP, Metal, Concrete, Other (Please State)	<input type="checkbox"/> Metal
Correct Asset Plate	<input type="checkbox"/> YES <input checked="" type="checkbox"/> N/A	If Cover is metal, is it within 250mm of current rail ?	<input checked="" type="checkbox"/> N/A
Gas Monitor Triggered	<input type="checkbox"/> YES <input checked="" type="checkbox"/> NO	Cover type - Solid, Grille, Mesh, Other (Please State)	<input type="checkbox"/> Solid
Step Irons, Access ladder	<input checked="" type="checkbox"/> YES <input type="checkbox"/> NO	Please list any defects below	
Chamber Cleaning Required	<input checked="" type="checkbox"/> YES <input type="checkbox"/> NO	Manhole had to be dug up to gain access to chamber due to lid rusting onto frame.

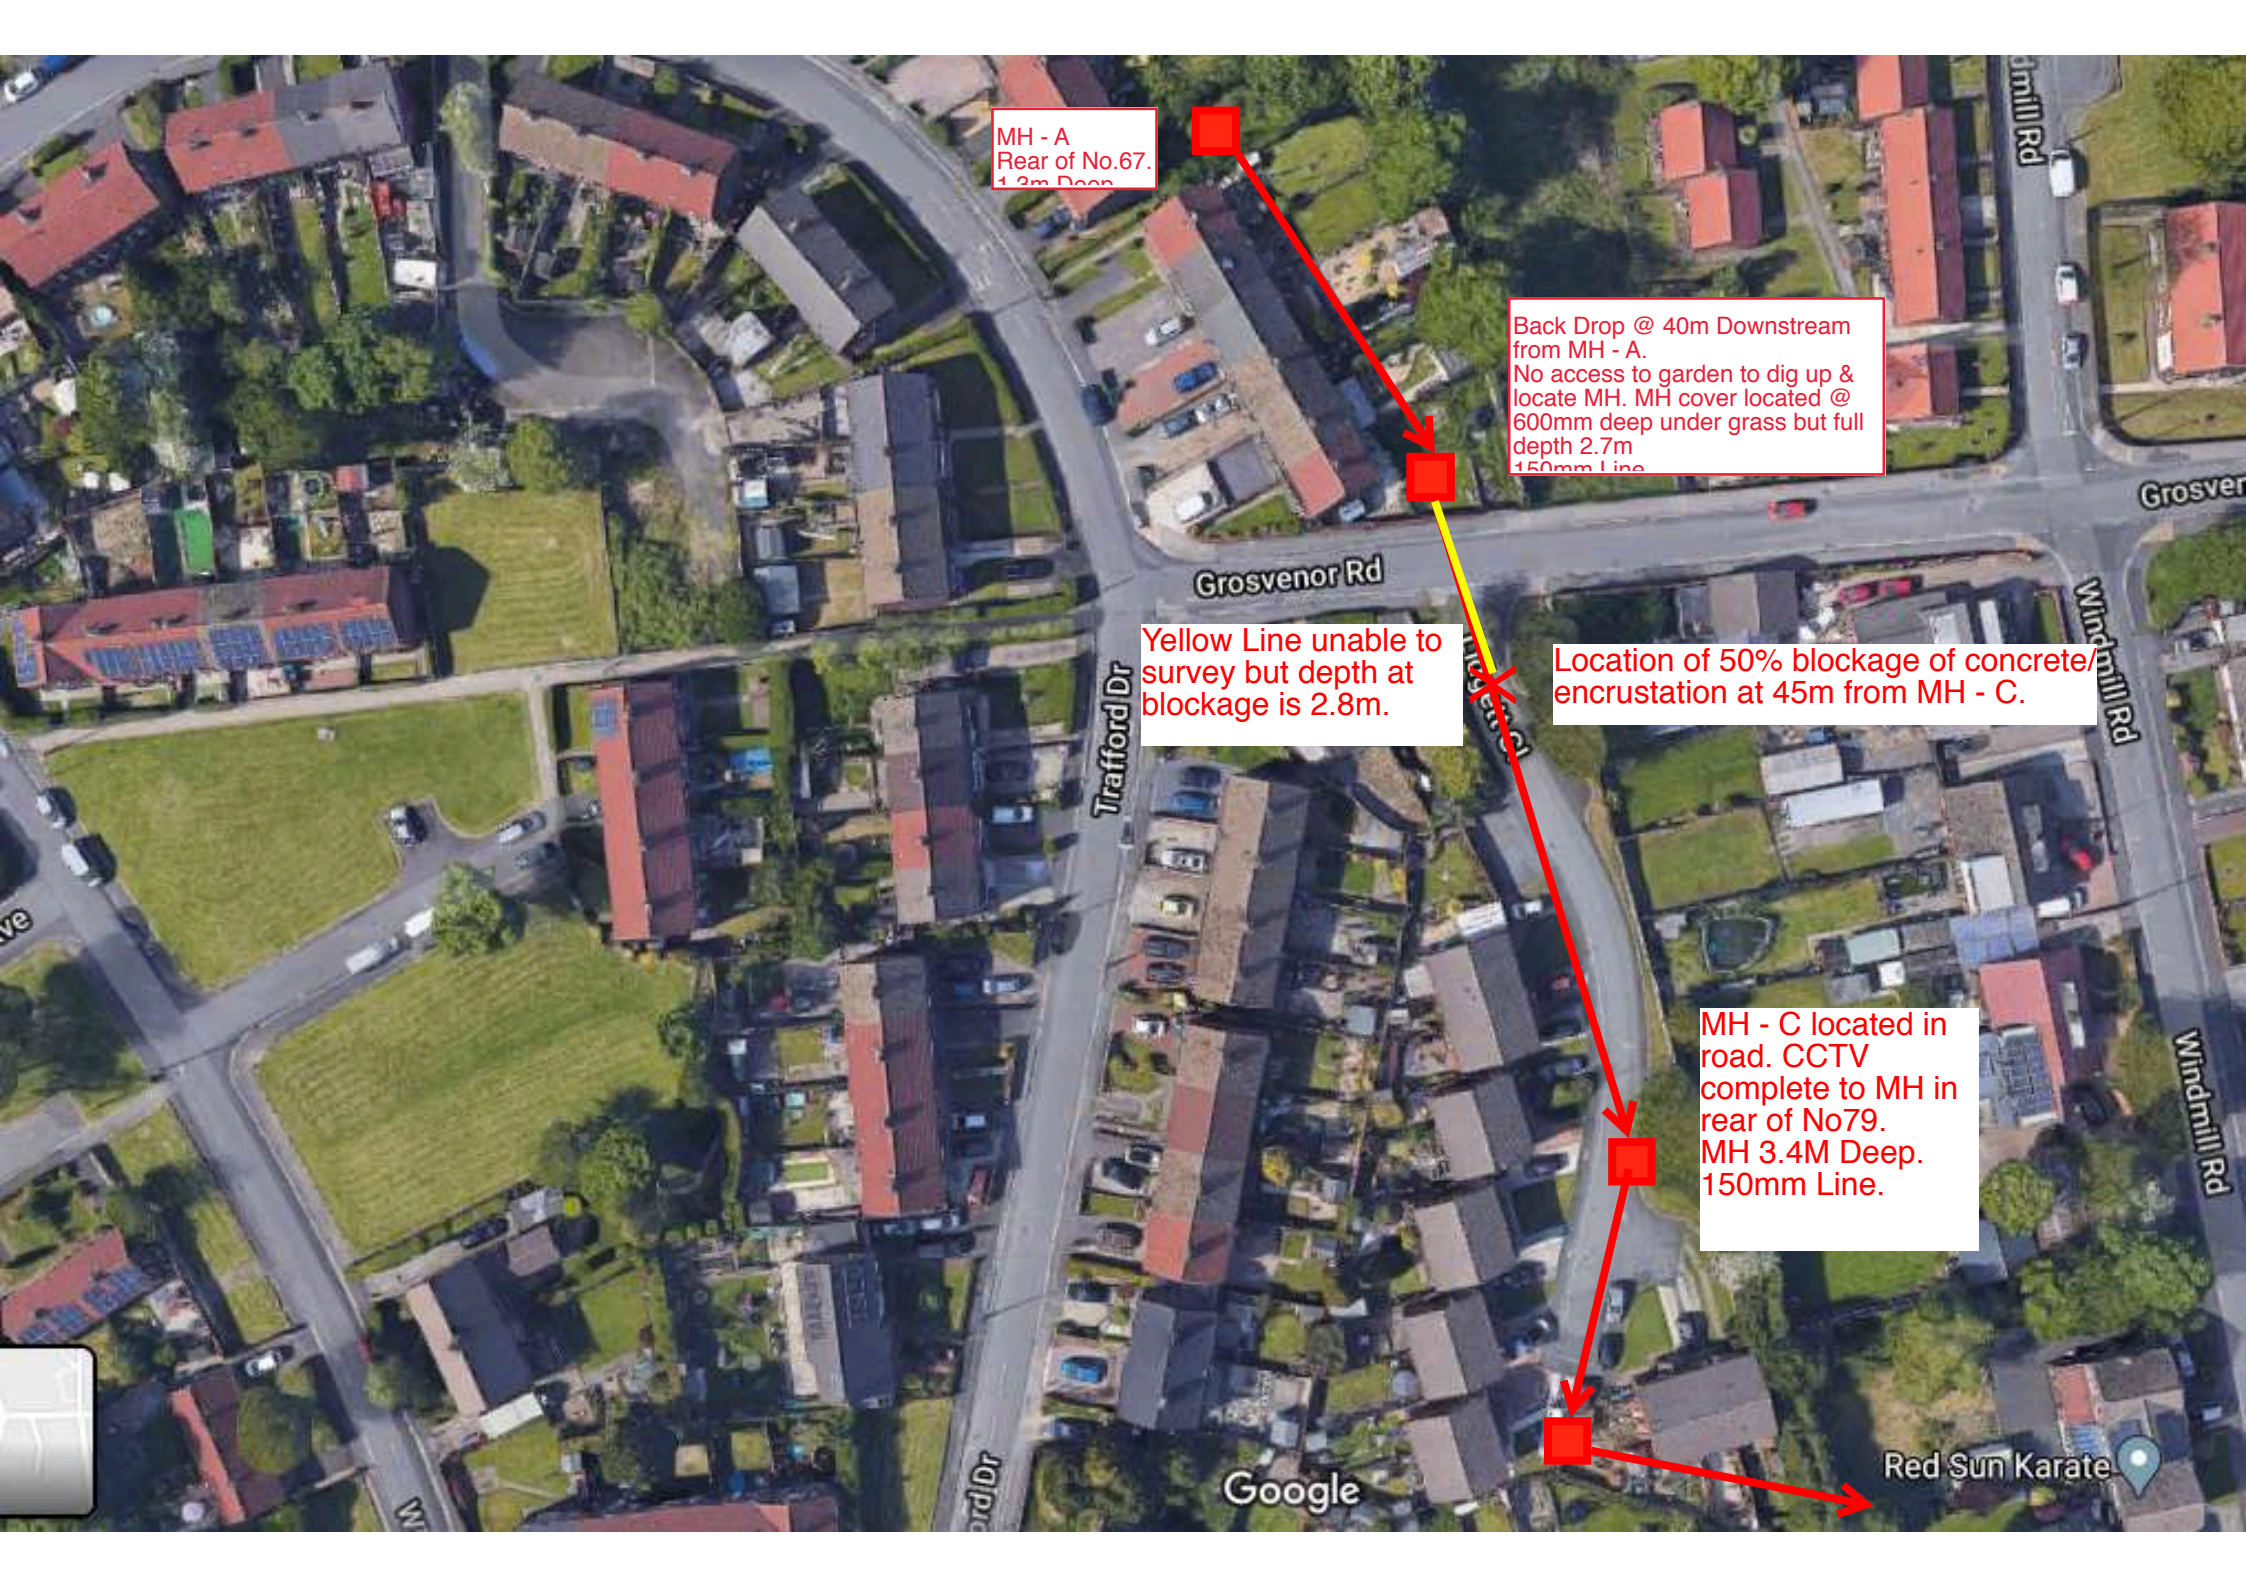
MH - A
Rear of No.67.
1.2m Deep

Back Drop @ 40m Downstream
from MH - A.
No access to garden to dig up &
locate MH. MH cover located @
600mm deep under grass but full
depth 2.7m
150mm Line

Yellow Line unable to
survey but depth at
blockage is 2.8m.

Location of 50% blockage of concrete/
encrustation at 45m from MH - C.

MH - C located in
road. CCTV
complete to MH in
rear of No79.
MH 3.4M Deep.
150mm Line.

The only way to confirm accurate depths will be to either clear the concrete blockage and survey upstream or unearth the buried manhole in the rear of No79 and survey downstream.

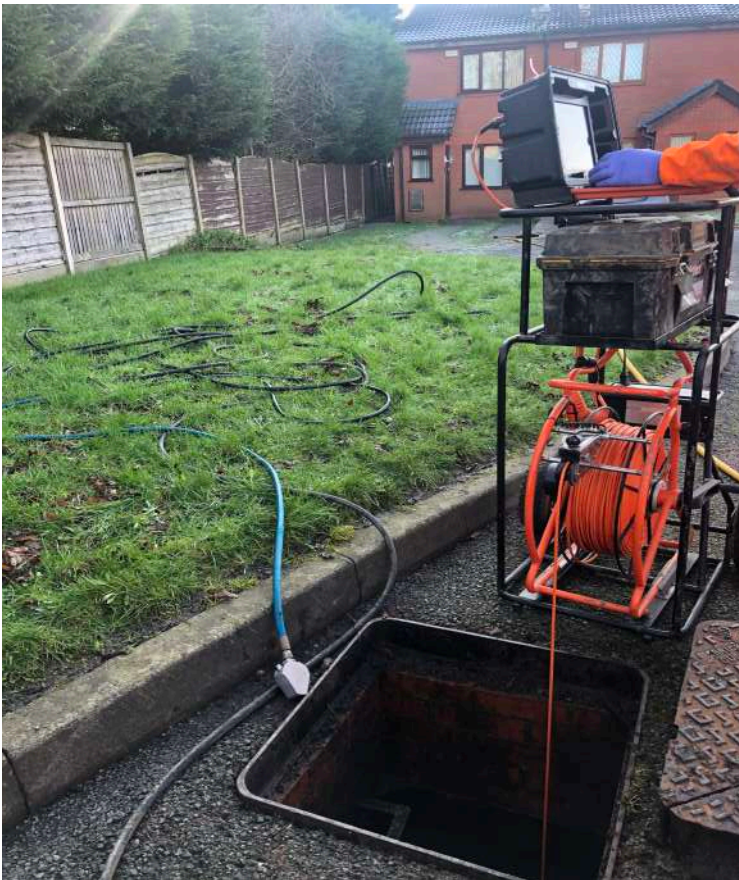
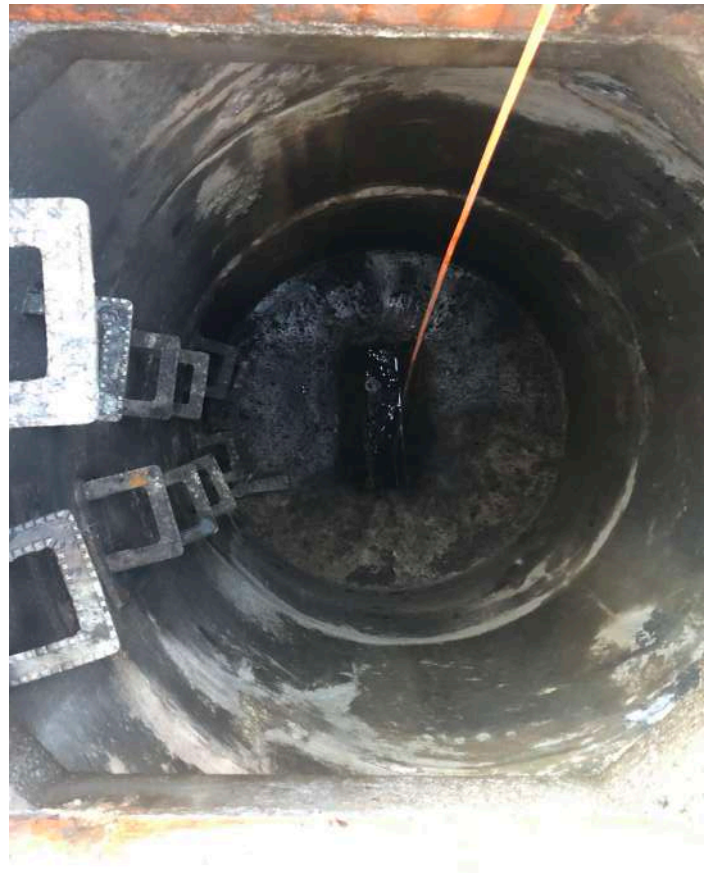
We then cross Grosvenor road and find a MH-C at approx 55m from Grosvenor Road, on Lidgett Close. This manhole is 3700mm deep to invert and has a 150mm line running through it, flowing in a Southerly direction. Chamber Inspection report attached.
