Further to us attending the above property on 27th January & Tuesday 4th February 2020, we can confirm our findings below :-

Surface water System

Foul Water System.

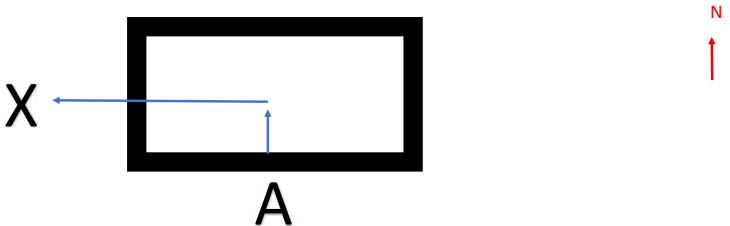
The Surface water system (SWS), at the South end of the site, was found to run from the junction of Lidgett Close and Grosvenor road, MH03, to the West and into MH04 and then flow in a southerly direction down Trafford Drive. See marked up plan attached.

This section was in a good condition, of 225mm diameter pipes and at a depth of 1400mm to the invert of MH03. Chamber inspection report attached along with the drainage report for the incoming and outgoing pipes.

Date	04.02.2020																																	
Location	Trafford Drive.																																	
Asset Reference	MH03																																	
Asset location	JCT of Grosvenor Rd & Lidgett Close																																	
Asset Type (manhole, catchpit, bailing pit, other)	Manhole																																	
Inspection Completed	<input checked="" type="checkbox"/> YES																																	
Wet Beds, signs of flooding	<input type="checkbox"/> NO	Chamber Construction - Brick, Concrete, GRP, Other (Please State)	Brick																															
Cover Obstructed	<input type="checkbox"/> NO	Cover Material - GRP, Metal, Concrete, Other (Please State)	Metal																															
Correct Asset Plate	<input type="checkbox"/> N/A	If cover is metal, is it within 250mm of current rail ?	N/A																															
Gas Monitor Triggered	<input type="checkbox"/> NO	Cover type - Solid, Grille, Mesh, Other (Please State)	Solid																															
Step Irons, Access ladder	<input checked="" type="checkbox"/> YES	Please list any defects below																																
Chamber Cleaning Required	<input type="checkbox"/> NO																																	
Covers Require Replacing	<input type="checkbox"/> NO																																	
Top Ring Damaged	<input type="checkbox"/> NO																																	
Chamber Surcharged	<input type="checkbox"/> NO																																	
Internal chamber Size	mm

This could present an opportunity to make a further surface water connection into, subject to the relevant approvals being obtained.

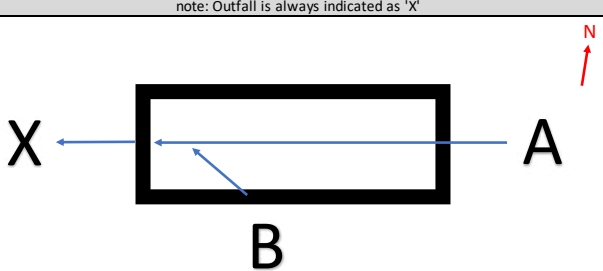
The SWS at the North West of the site was found to be located in the front garden of No.53, MH01, and was showing signs of neglect. We jetted the lines coming into MH01 to try and obtain CCTV footage but all lines are surcharged and require a full cleanse from UU. MH01 was also found to have a substantial amount of slit/soil in the bottom but we did manage to find the incoming assets x2 and outgoing asset x 1. These were all 150mm in diameter and between 1850mm & 1900mm deep to invert in MH01.

MH01 - Washed down.
Lines found and MH
good to connect into.
MH 1.9m deep

Contractors Inspector	Leon Schofield	
Date	04.02.2020	
Location	Trafford Drive.	
Asset Reference	MH01	
Asset location	Front garden of No.53.	
Asset Type (manhole, catchpit, bailing pit, other)	Manhole	
Inspection Completed	<input checked="" type="checkbox"/> YES

Wet Beds, signs of flooding	<input type="checkbox"/> YES <input checked="" type="checkbox"/> NO	Chamber Construction - Brick, Concrete, GRP, Other (Please State)	<input type="checkbox"/> Brick
Cover Obstructed	<input checked="" type="checkbox"/> YES <input type="checkbox"/> NO	Cover Material - GRP, Metal, Concrete, Other (Please State)	<input type="checkbox"/> Metal
Correct Asset Plate	<input type="checkbox"/> YES <input checked="" type="checkbox"/> N/A	If Cover is metal, is it within 250mm of current rail ?	<input checked="" type="checkbox"/> N/A
Gas Monitor Triggered	<input type="checkbox"/> YES <input checked="" type="checkbox"/> NO	Cover type - Solid, Grille, Mesh, Other (Please State)	<input type="checkbox"/> Solid
Step Irons, Access ladder	<input checked="" type="checkbox"/> YES <input type="checkbox"/> NO	Please list any defects below	
Chamber Cleaning Required	<input checked="" type="checkbox"/> YES <input type="checkbox"/> NO	Manhole had to be dug up to gain access to chamber due to lid rusting onto frame.

Covers Require Replacing	<input type="checkbox"/> YES <input checked="" type="checkbox"/> NO		
Top Ring Damaged	<input type="checkbox"/> YES <input checked="" type="checkbox"/> NO		
Chamber Surcharged	<input type="checkbox"/> YES <input checked="" type="checkbox"/> NO

This MH01 does have a potential inlet of 150mm at the North Easterly side which could potentially take the SWS from the proposed new site.
